DEPARTMENT OF THE ARMY
U.S. ARMY CORPS OF ENGINEERS
BOISE REGULATORY OFFICE
720 EAST PARK BOULEVARD, SUITE 245
BOISE, IDAHO 83712-7757

SUBJECT: NWW-2004-0600046, US-95 Thorn Creek Road to Moscow, KN 09294

DHP-NH-4110(156) US-95,
THORN CR RD TO MOSCOW, PH 1

Thorn Creek Road to Moscow Wetland Delineation Review and
Technical Report for Areas within the US-95 E-2 Alignment - September 22, 2020

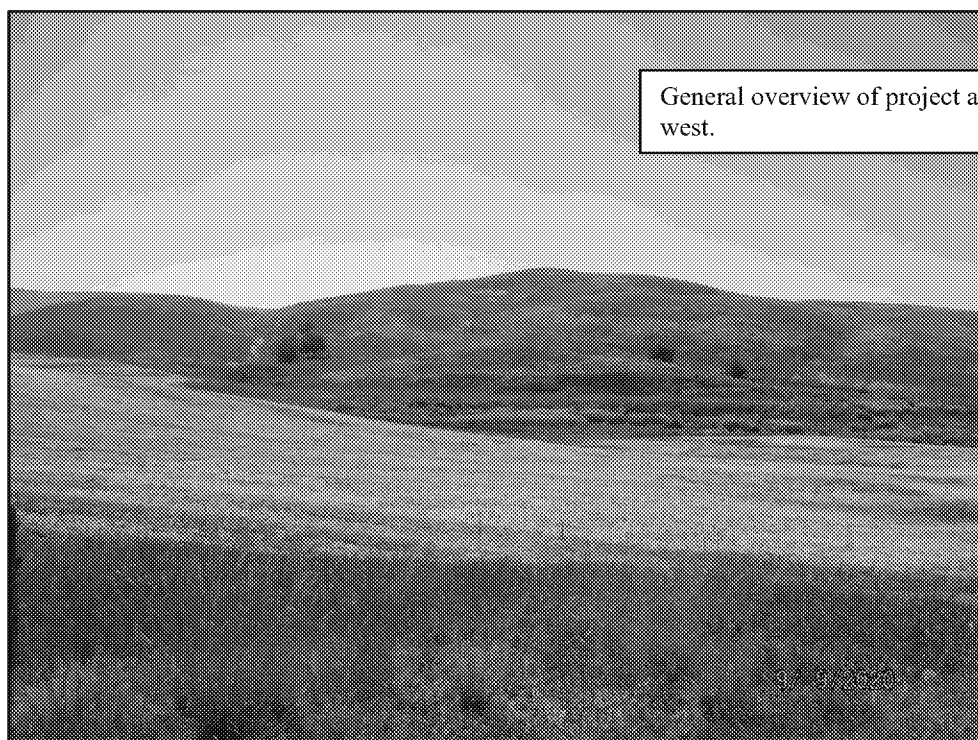
General overview of project area, looking west.

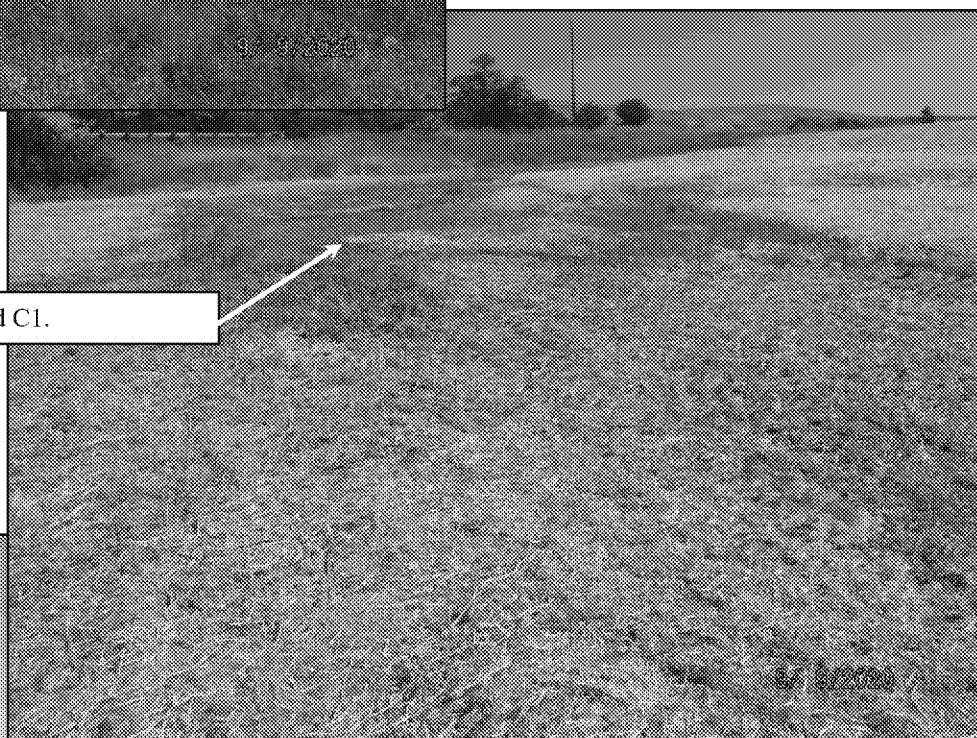
Wetland C1 is an emergent wetland in an annually cropped agricultural field. The field had been planted to spring peas and harvested this fall. A small area on the field's northern side was sparsely vegetated, had a cracked soil surface, and farm equipment tire tracks presumably left from when the soils were saturated in the spring of the year. Some scented mayweed was present in the wetland boundaries. Test sites (C1 and C2) were used to verify wetland boundaries. Because the soils within the wetland boundaries were not saturated during this field visit, which was performed during the dry period of the growing season, the wetland area was determined to be the area where a spring crop did not survive, and the non-wetland area was based on the survival of the spring pea crop and its chaff, which was still present in the field.

Looking east at Wetland C1.

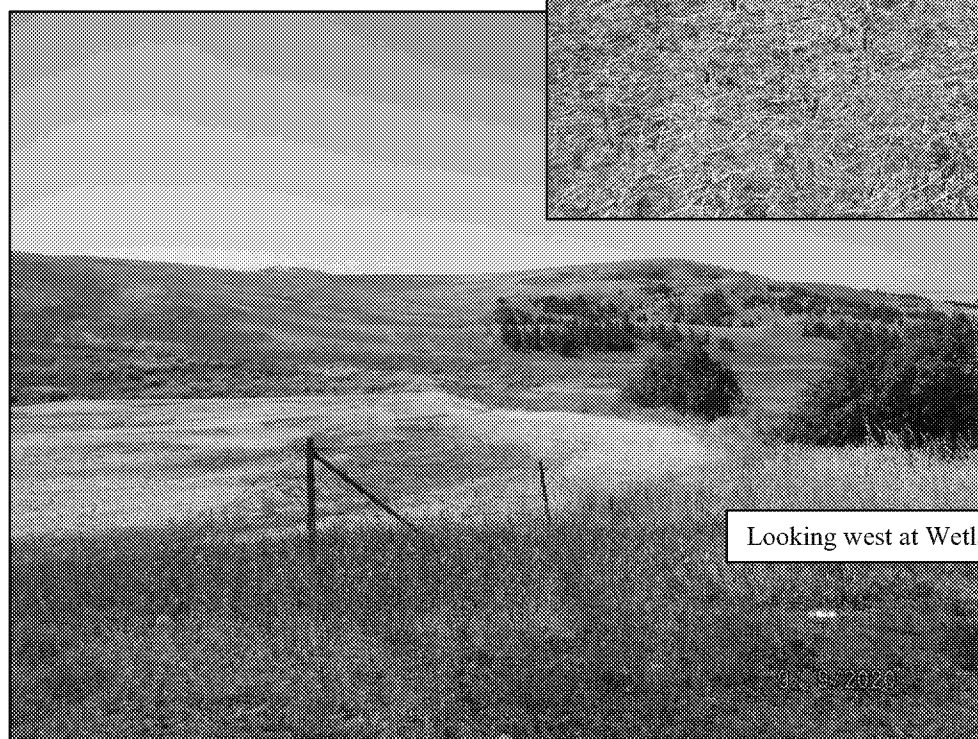
Looking west at Wetland C1.

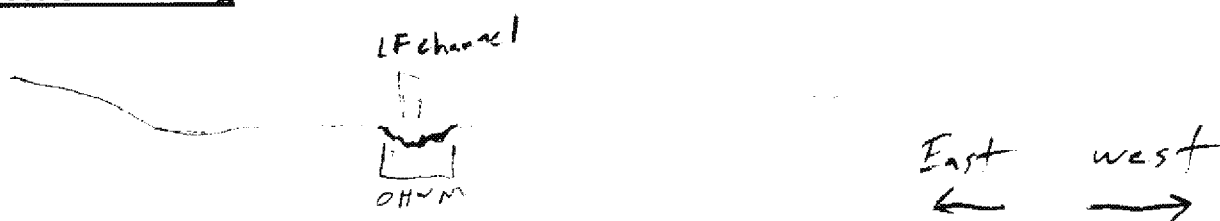
Cross section drawing:

Project ID: T2M Cross section ID: CS10 Date: 9/14/26 Time: 3:00 PM

OHWM
